USACERL TECHNICAL REPORT N-89/08

## Sediment Control at Army Training Areas Case Study:

Hohenfels, Federal Republic of Germany

by Robert E. Riggins Winifred Hodge Robert M. Lacey Timothy J. Ward

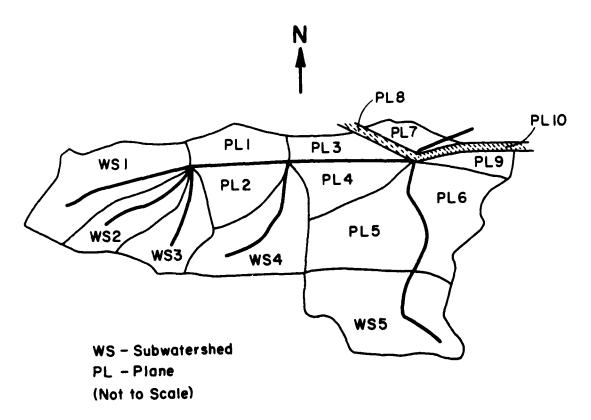
Figure 2. The Madental Watershed.

The analysis was conducted using the Madental Watershed (Figure 2). The watershed is about 2000 acres (810 ha). For simulation, the area was divided into 5 subwatersheds, 10 planes, and 7 channels. A schematic for the computational sequence is shown in Figure 3.

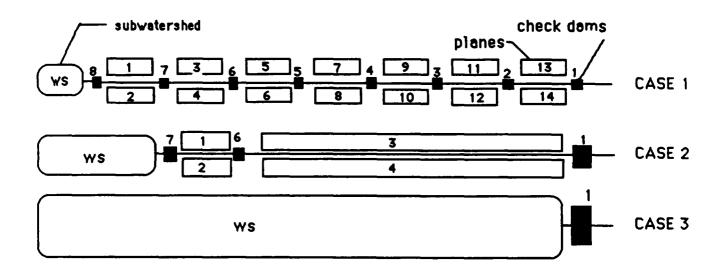
Figure 4. A schematic for comparing various numbers of structures.

one 25 acre-ft (3 ha-m) structure at the outlet. Table 5 shows the results. Figure 4 shows the schematic for the three cases.

The results show that several smaller structures will reduce the peak flow. There is no significant difference in sediment yield shown in these simulations. While this does not indicate that a single, larger structure is better in terms of sediment reduction, it does indicate that smaller structures can be combined into a single, larger structure to reduce the work involved in simulation.
